# VILLAGE OF LOMBARD AVOIDS DISRUPTION WITH INNOVATIVE WATERMAIN LINING PROJECT

By: Carl Goldsmith and Avis Meade, Village of Lombard

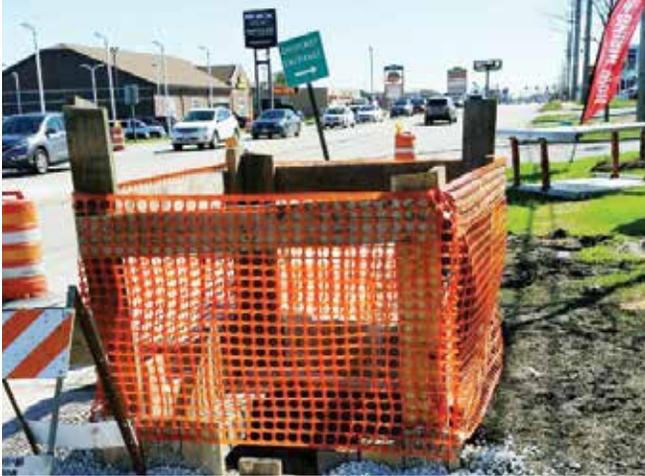
Access pits situated to minimize disruption to traffic

First, a temporary water system was installed to provide customers access to water when the watermain is shutdown. After this, the access pits were excavated and shoring boxes installed into each pit. Road plates allowed traffic to pass over these access pits when construction was not taking place.

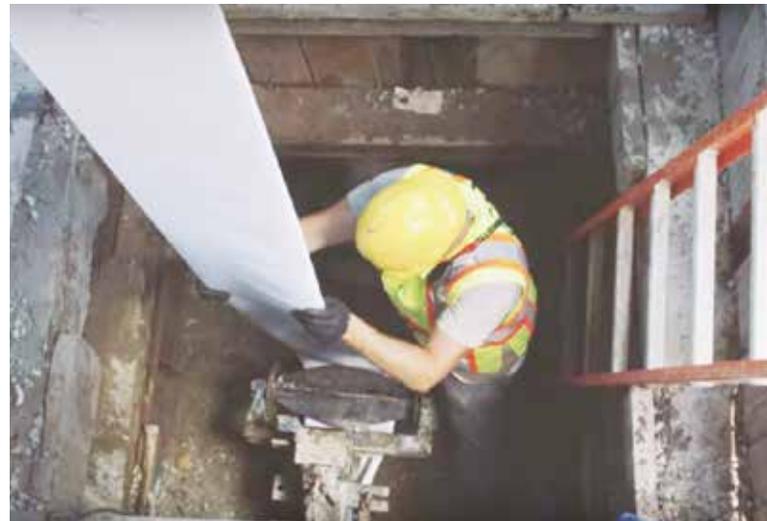
*More than one million miles of Aqua-Pipe CIPP liner have been installed in watermains across North America*

Used across North America to rehabilitate watermains, CIPP works by inserting a woven liner injected with epoxy resin into the existing watermain. This liner has the equivalent structure of a brand new watermain, giving it new life.

Once the access pits were installed the watermain was cleaned and a video of the cleaned watermain was recorded. Next, the inside of the watermain was scanned to size the Aqua-Pipe CIPP liner. Once the size was determined, the liner was pulled into place, then cured and hardened by using hot water. Once cured, the watermain was tested and videoed to ensure a quality product was installed.
